DUFFY HOME INSPECTION SERVICE, INC.

DATE OF INSPECTION: 6-19-2009.
TIME OF INSPECTION: 1:00 pm.
CLIENT NAME: Mr. Brian Boynton.
PHONE #: 770-427-2488.
E-MAIL ADDRESS: hana.boynton@gmail.com.

4850 Karls Gate
Drive.

Marietta, GA 30068.

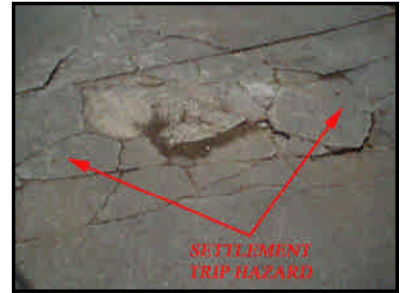
DRIVE CONDITION: Some sections of the driveway have cracked and raised or settled (*trip hazard*), repair or replace as necessary to eliminate the trip hazard. This is a good indication the soil was not compacted under the concrete before it was installed.

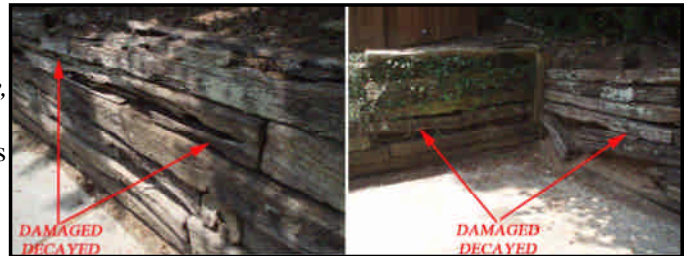
RETAINING WALL CONDITION: Some section of the retaining wall have collapsed (*right side, back corner*), and most of the members in other areas are decayed, replace the entire retaining wall as needed.

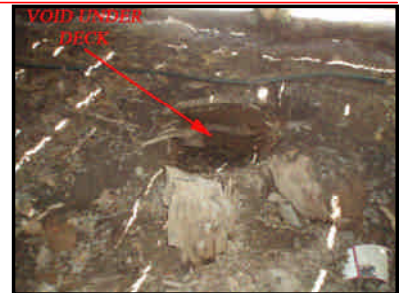
REAR GRADE: Voids noted in the back yard area (*under the deck, area around old tree stump*), repair as needed to prevent water from collecting.

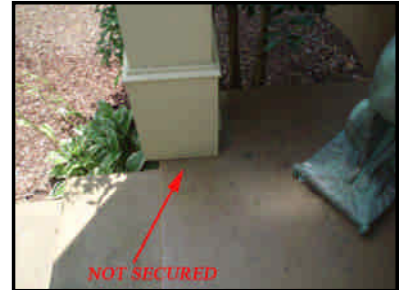
VERTICAL
SUPPORT
CONDITION: The vertical supports are not secured at the base. Vertical supports should be restrained to prevent lateral displacement at the bottom.

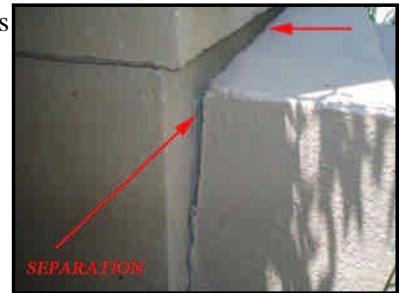
PORCH , STAIR(S)
CONDITION: Settlement, separation and rotation noted, this is a good indication the soil was not compacted under the concrete before it was installed, repair / replace as needed.

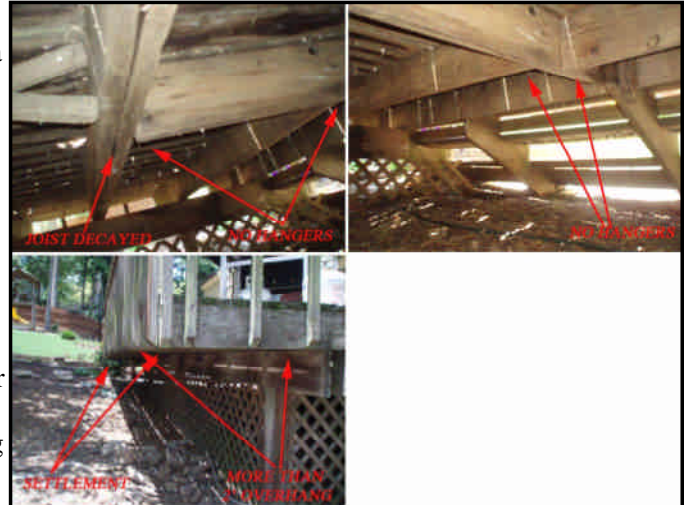
1. Some of the deck boards and joist area decayed.
2. The back section of the deck overhangs the beam more than 2 feet (*some settlement noted, should not be more than 2 feet*).
3. There were no joist hangers / ledger installed (*some areas*). Joist framing into the side of a wood girder / beam should be supported by approved framing anchors or on ledger strips not less than 2x2.
4. Overall the deck is in poor condition and should be replaced. *See other deck comments below.*

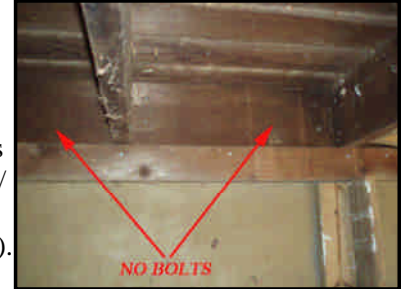
The deck is not secured to the house with bolts. Where supported by attachment to an exterior wall, decks shall be positively anchored to the primary structure and designed for both vertical and lateral loads as applicable. The deck should be bolted with 1/2" hex thru-bolts with flat washers on both sides and spaced 12" to 24" (see Deck Detail).

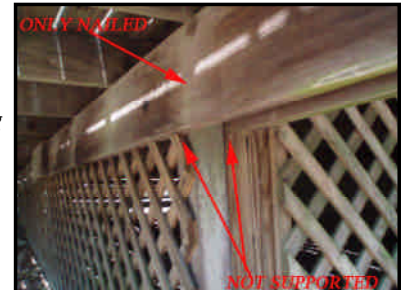
The back beam members are only nailed to the vertical supports. Generally, the supports are notched at the top to accept the single members. *See comments regarding replacing the deck.*

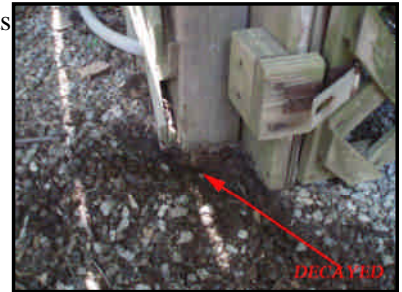
Damage / Decay noted at the base of the posts
(back left, check all). See comments
regarding replacing the deck.

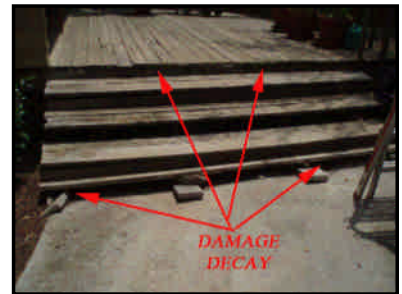
See comments regarding replacing the deck.

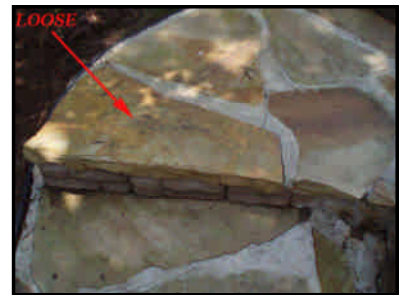
Some of the stones are loose (check all
areas), repair as needed.

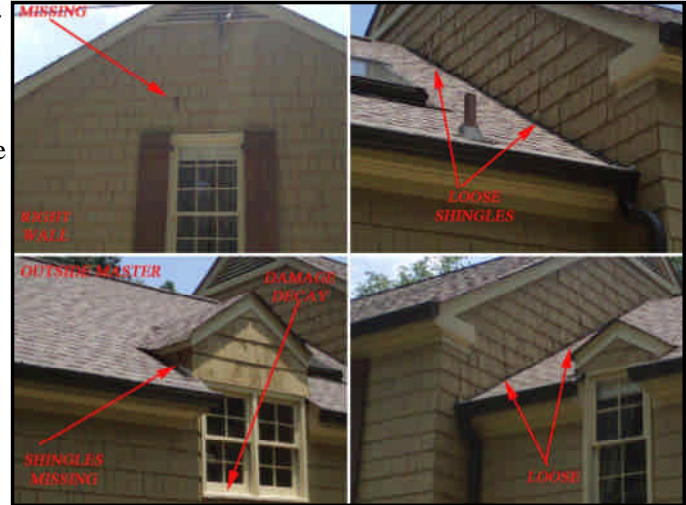
1. Loose, missing or damaged shingles noted, right wall (*above master window*), right gable wall (*above the master bedroom, front and back, check all areas around the home*).
2. Shingles missing, back right dormer outside the master bedroom (*right side, top edge of flashing not covered*). All

exterior walls should be covered with approved materials designed and installed to provide a barrier against the weather and insects to enable environmental control of the interior spaces.

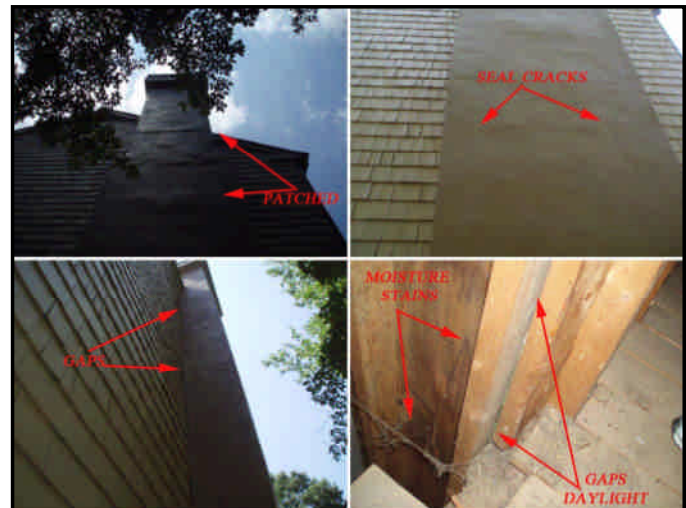
1. Evidence of prior patching (*chimney area, inquire with the homeowner*).
2. Adequate caulking is needed, where the corner boards come in contact with the stucco (*daylight visible in the attic*). All the seams / penetrations in the building envelope, that are sources of moisture entry or air leakage, should be sealed.

3. Cracks noted in the stucco (*seal as needed*). Be aware when cracks are sealed / patched in stucco it is not always possible to match the existing finish. I recommend consulting with a stucco contractor as to the best method for sealing the cracks. *See moisture comments interior section of the report.*

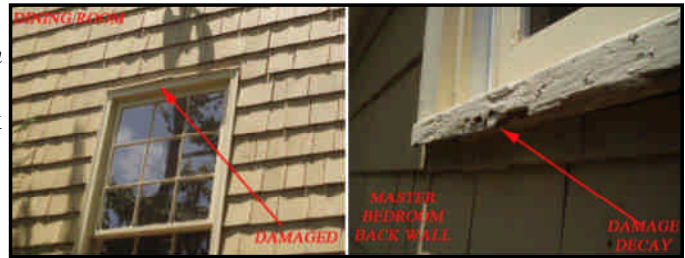
TRIM CONDITION: Damage / Decay noted, left wall (*trim above the dining room window*), back wall (*window sill outside the master bedroom*), replace all damaged / decayed sections of trim around the home.

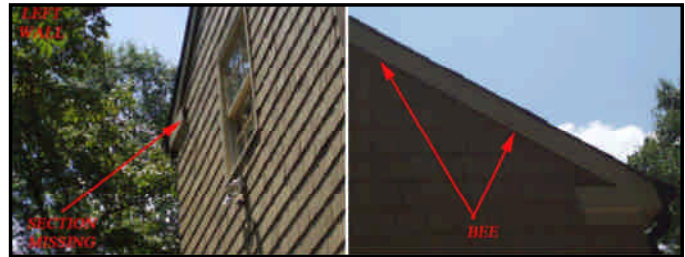
1. Some carpenter bee activity noted.
2. Section of fascia board missing, left wall (*back corner*), install as needed.

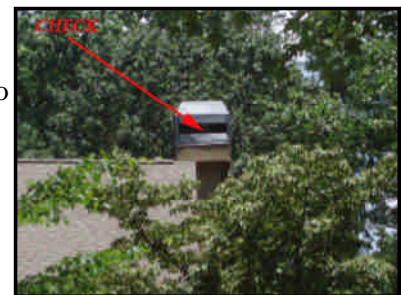
1. See stucco comments.
2. The back section of the chimney cap is kinked and make sure it's properly attached to the chimney.

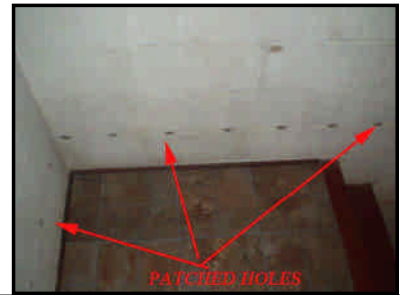
OPINION: Patched holes noted in the floor of the basement. This indicates these areas were treated for termites in the past.

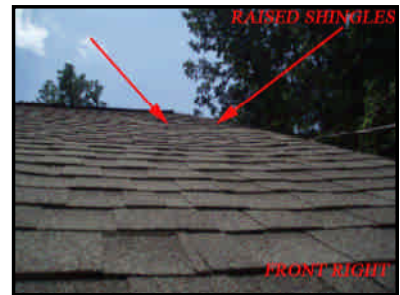
ROOF COVERING STATUS: Some of the shingles are buckled / raised (front right above the master), repair as needed. See attic roof sheathing comments.

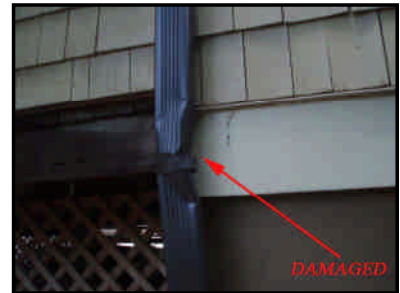
TYPE: Full, Aluminum.
GUTTER
CONDITION: 1. Damaged downspout(s) noted, left side
(back corner), replace as needed.
2. I recommend routing **all** the downspouts
away from the building. This will help with
drainage around the foundation.

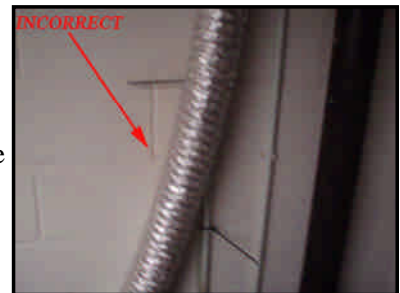
DRYER VENTING: 1. Unable to view 2nd floor unit. **NOTE:** Lint can built-up in the dryer vent over time, recommend it be cleaned on a yearly basis.
2. Incorrect type of venting material used (basement). The dryer exhaust duct should be constructed of rigid metal (aluminum or galvanized steel). The interior of the duct should be smooth surface with the joints running in the direction of the airflow. There should be no sheet-metal screws, rivets or any other fastener used to connect the duct joints. Fasteners that extend into the airway will catch lint and obstruct airflow. Clamps or foil duct tape should be used to secure the joints.

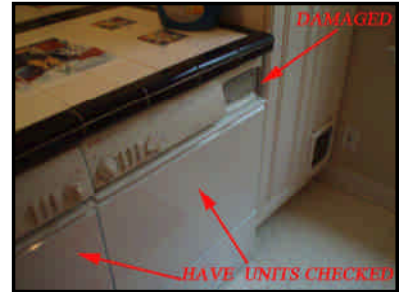
1. Part of the 2nd floor washer is damaged, repair / replace as needed.
2. Testing the washer / dryer is beyond the scope of the inspection, I recommend having both checked to make sure they run a full cycle. *Unable to view behind the units.*

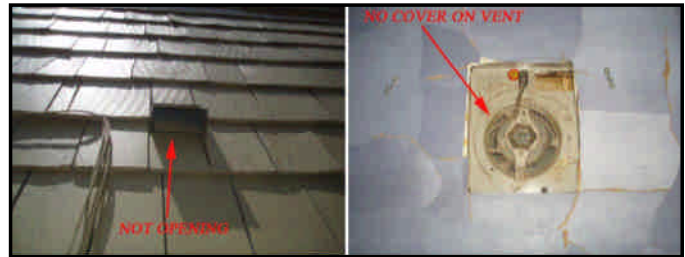
All exhaust vents should be equipped with a backdraft damper.

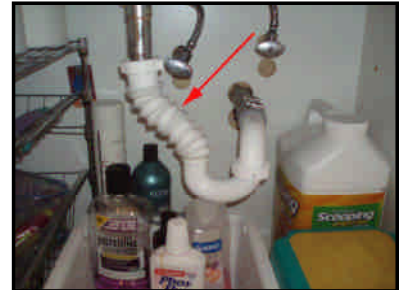
BATH LOCATION: Hall, Upstairs.
CONDITION OF SINK: Appears serviceable.
FAUCET CONDITION: Faucet is serviceable.
DRAIN LINE: Incorrect section of drain line used (*hall bathroom*), replace as needed.

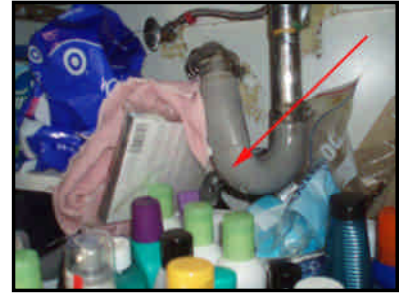
DRAIN LINE: Incorrect section of drain line used (*master, both sinks*), replace as needed.

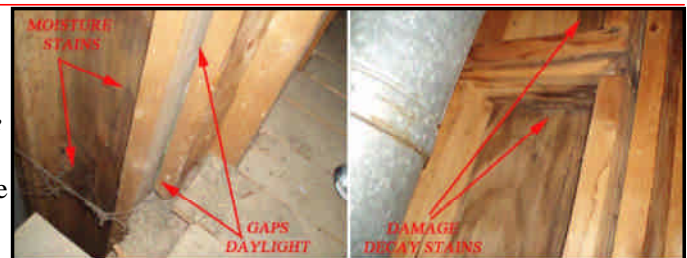
STAIN ATTIC: Moisture stains noted in the attic (*wood framing around the fireplace vent*). These areas tested dry at the time of the inspection. However, the stains are an indication that there was a leak in the past, I recommend inquiring with the homeowner regarding the stain. *See stucco comments / recommendations.*

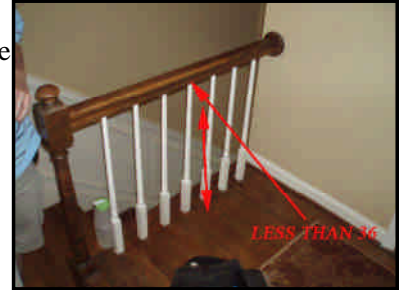
STAIR CONDITION: 1. The handrail is not continuous the full length of the stairs, all handrails should be the full length of the stairs and the ends should return into the wall or a newel post.
2. The sturdiness of the handrail / guardrail needs further evaluated for safety (*bottom*). Guardrails and handrails should be able to withstand 200 pounds per square foot in any direction at any point along the top.
3. The openings in the rails are too wide (*balusters exceed the required 4 inches*), and the top of the guardrail is less than 36" above the floor surface. These upgrades are recommended for safety enhancement.

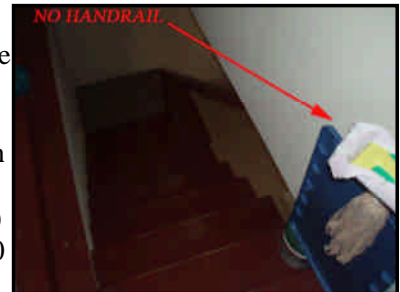
1. The handrail is not continuous the full length of the stairs, all handrails should be the full length of the stairs and the ends should return into the wall or a newel post.
2. No guardrail(s). Open side(s) of stairs with a total rise of more than 30 inches above the floor or grade below should have guardrail(s) having minimum and maximum heights of 30 inches and 38 inches respectively, measured vertically from the nosing of the treads. Upgrades are recommended for safety enhancement.

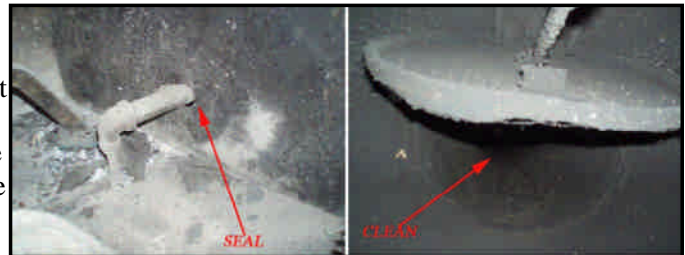
1. The hole around the gas pipe has not been sealed, where it comes through the fire brick. The space between the gas pipe and the sleeve should be sealed with a high-temperature compound to prevent hot embers from endangering adjacent combustible surfaces.
2. The flue needs cleaning. I recommend having the chimney cleaned and serviced by a CSIA Certified Chimney Sweep. Obtain a work-order showing this service has been performed.

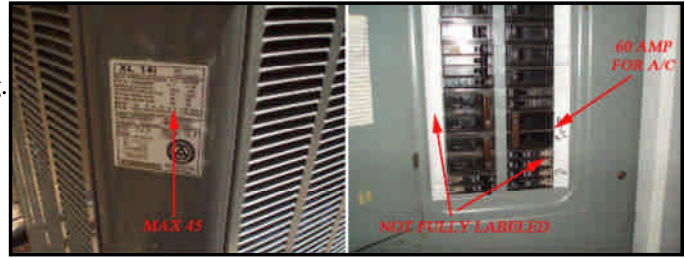
1. The panel(s) is without the benefit of complete labeling. The use or purpose of all panelboard circuits should be legible marked and identified on a

circuit directory located on the face or inside the door of the enclosure.

2. The breaker(s) is oversized for of the Air Conditioning unit(s), 60 amp installed, should be 45 amp max or 40 amp min. Heating and cooling equipment should be installed in accordance with the manufacturer's installation instructions.

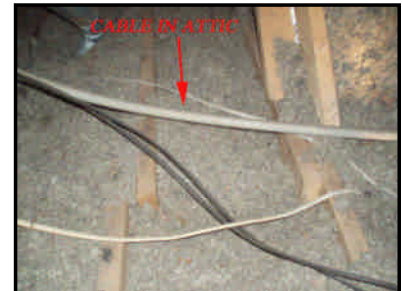
I noted the entrance cable from the meter to the panel is located in the attic area. I recommend the cable not be covered with insulation if / when its added in the attic (*could overheat cables, causing fire*).

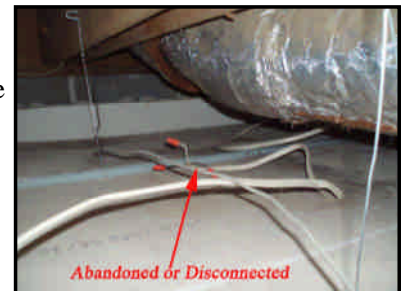
Some abandoned or disconnected wiring noted, basement (*above the ceiling*). A box (or fitting) should be installed wherever there are splices, outlets, switches, or other junction points.

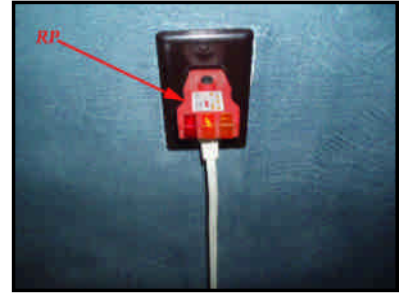
Reverse polarity noted, basement workout room (front wall, left side). Listed or labeled equipment shall be installed and used in accordance with any instructions included in the listing or labeling. *Note: Not all the outlets were tested, because of furniture and storage items.*

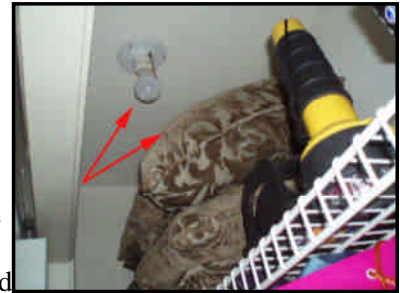
1. Lights are not operational in some areas, back left bedroom, possibly due to bad bulbs or no bulbs, have them checked.
2. Bare incandescent lamps noted in some of the closets (check all). Clothing, boxes, and other material normally stored in clothes closets are a potential fire hazard. Have these fixtures replaced with surface mounted incandescent fixture with completely enclosed lamps, recessed incandescent fixture with completely enclosed lamps, surface fluorescent fixture, or recessed fluorescent fixture. This upgrade is recommended for safety enhancement.

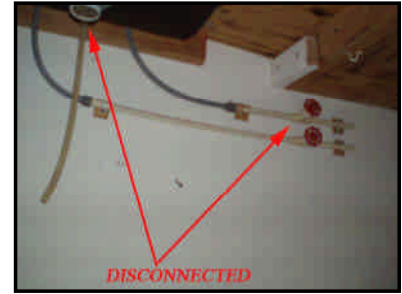
1. See laundry comments.
2. The sink has been disconnected in the basement (*drain line supply lines*).

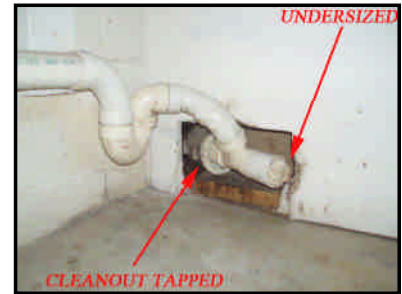
Some of the cleanouts in the basement have been tapped into (*dehumidifier*). Cleanouts are required should the waste line become clogged by an accumulation of waste or tree roots.

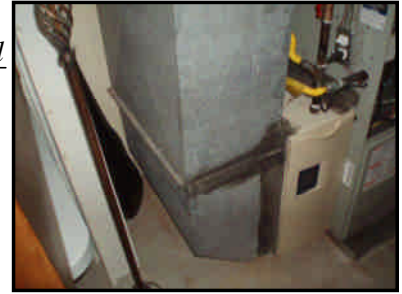
AIR PLENUM: No insulation installed on the return air plenum(s) and ductwork in the basement. All ductwork installed in non-conditioned areas should be insulated. *See service comments. This should have been upgraded when the new furnace was installed.*

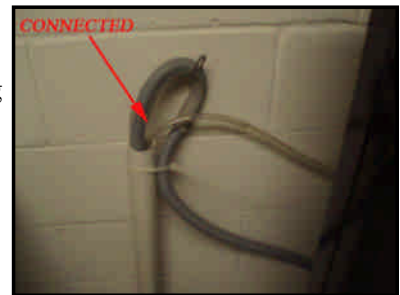
CONDENSATE LINE(S): Condensate pump line is installed but it is connected to the laundry drain line, this condition does not comply with the plumbing code. *See service comments.*

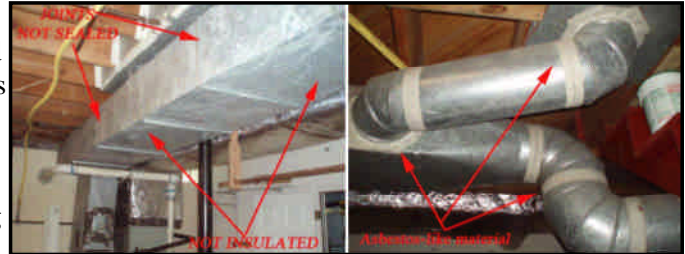
1. ASBESTOS-LIKE material noted on some of the joints of the ductwork.
 2. Air leaks noted.
- All of the ductwork needs proper sealing to prevent air

leakage in nonconditioned areas (*supply / return*). All joints should be securely fastened and sealed with welds, gaskets, mastic adhesives, mastic-plus-embedded-fabric systems or tapes. *See service comments. This should have been upgraded when the new furnace was installed.*

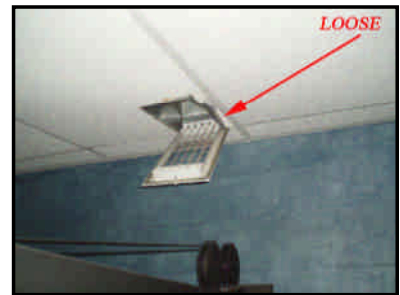
Loose register noted, basement (*workout room*), repair as needed.

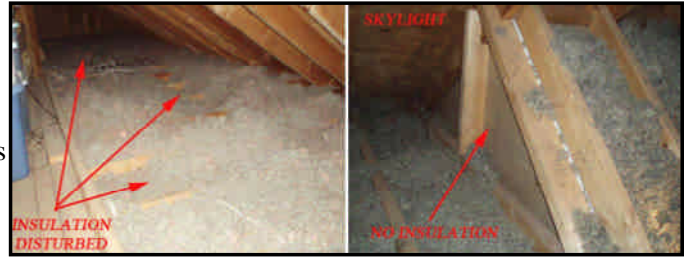
1. Sections of insulation missing, area around the skylight.
2. The insulation has been disturbed and good coverage is no longer present in several areas.

3. I recommend additional insulation in the attic area, depending on the type of insulation, 8.11 inches to 14 inches is recommended for R-30. (*see entrance cable comments / recommendations*). **Note: Before adding insulation above the bonus area make sure the recessed light fixtures are rated for insulation contact.**

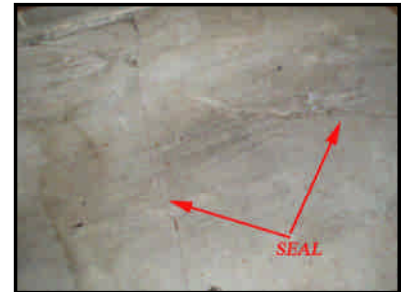
Cracks noted in the exposed floor area. I recommend cracks be sealed and monitored for further movement. If cracks reappear or get larger, consult with a structural engineer.

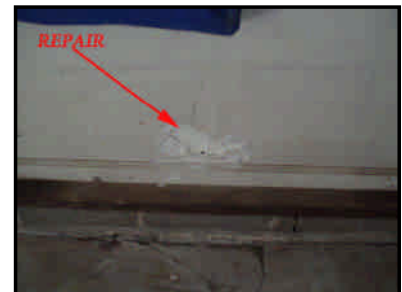
Drywall. Some holes noted in the drywall, repair any openings with approved materials to restore its fire rating.

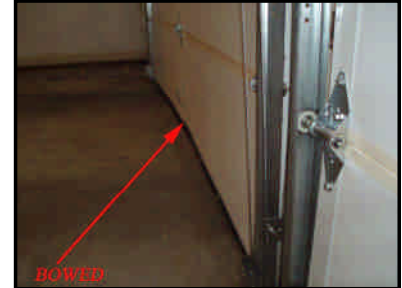
The bottom panel of the "back" door is damage / bowed, replace as needed.

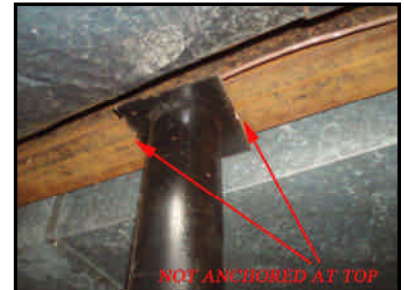
V. SUPPORT CONDITION: The vertical supports are not secured at the top where they are connected to the deck. Vertical supports should be restrained to prevent lateral displacement at the top.
