DUFFY HOME INSPECTION SERVICE, INC.

DATE OF INSPECTION: 6-19-2009.
TIME OF INSPECTION: 1:00 pm.
CLIENT NAME: Mr. Brian Boynton.
PHONE #: 770-427-2488.
E-MAIL ADDRESS: hana.boynton@gmail.com.

4850 Karls Gate
Drive.

Marietta, GA 30068.

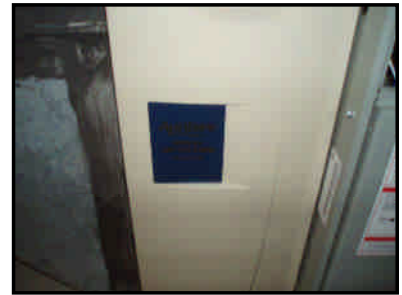
AIR FILTERS TYPE / CONDITION: Disposable, Appear serviceable.
 AIR FILTER LOCATION(S): In the return plenum next to the furnace.
 AIR FILTER SIZE: Aprilaire, High Efficiency, Model # 2200.

NORMAL CONTROLS: Appear serviceable.
 GENERAL SUGGESTIONS: I recommend having your system service annually (indoor / outdoor units) by a licensed Heating and Air Conditioning contractor - change filter(s) every 30 to 60 days. For more information on filters (see page 28, in the Home Maintenance book).

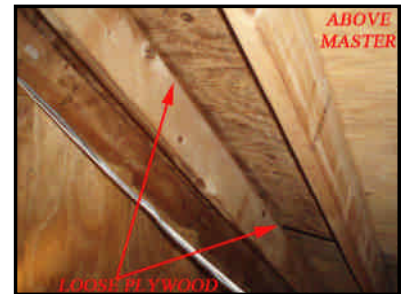
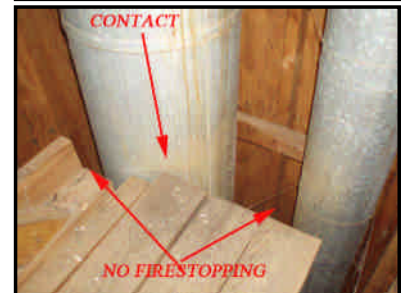
ATTIC ENTRANCE LOCATION:	Hallway, upstairs.
ACCESSIBILITY:	Pull down stairs.
METHOD USED TO OBSERVE:	Entered Accessible areas, attic insulation restricted viewing.
ATTIC FRAMING TYPE:	Conventional framing, Rafter Framing, 2X6 @ 16" O/C, Joist Framing, 2X8 @ 16" O/C.
FRAMING CONDITION:	Appears serviceable.
PURLIN CONDITION:	Appears serviceable.
ROOF SHEATHING:	Loose section of plywood noted, front right above the master. Insufficient fastening, especially at panel ends, permits excessive panel movement and flexure. Panels should be fastened 6" O.C along panel ends and 12" O.C along intermediate framing members. <i>See roof shingle comments.</i>
FIRE STOPPING:	<ol style="list-style-type: none">1. Inadequate pipe clearance from combustible material (<i>fireplace vent pipe</i>). Appliances should be installed with the clearances from unprotected combustible materials as indicated on the appliance label and in the manufacturer's installation instructions.2. No firestopping (<i>open chase</i>) noted, area around the chimney vent. A chase is an opening in the attic floor area that could allow a fire, from the story below, to enter the attic area. Firestopping is required at each floor, at the attic floor and at all roof penetrations. <i>Note: Open chases also affect the heating and cooling of the home.</i>

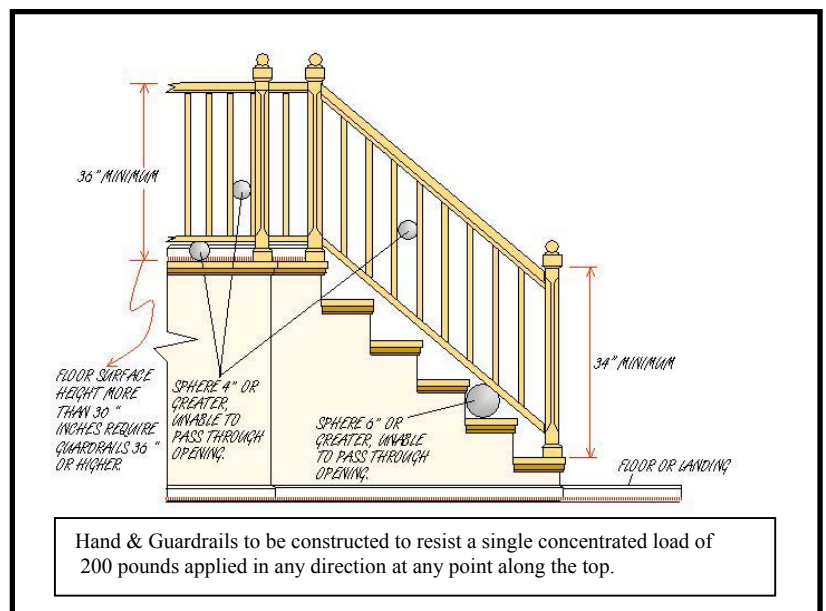
Figure 1. Handrail and Pickett Spacing.

Required guardrails on open sides of stairways, raised floor areas, balconies and porches shall have intermediate rails or ornamental closures which do not allow passage of an object 4 inches (102 mm) or more in diameter. (See Figure 1.)
